AIRCRAFT ACCIDENT INVESTIGATION
Private Bag 12042
Ausspannplatz
Windhoek
NAMIBIA

RE: AIRCRAFT INCIDENT REPORT

**DIRECTORATE OF AIRCRAFT ACCIDENT INVESTIGATIONS
ACCIDENT REPORT – EXECUTIVE SUMMARY**

Aircraft Registration	V5-HJB	Date of Accident	24 June 2014		Time of Accident	11:50 UTC
Type of Aircraft	ROBINSON R22 BETA 2	Type of Operation		Game capture		
Pilot-In-Command License Type	CPL (Helicopter)	Age	40	License Valid	Yes	
Pilot-In-Command Flying Experience	Total Flying Hours	4000.0 hrs		Hours on Type	3300.0 hrs	
Last point of departure	Farm Immenhof					
Next point of intended landing	Farm Immenhof					
Location of the accident site with reference to easily defined geographical points (GPS readings if possible)						
Farm Immenhof S 21° 06' 55" E 015° 35' 36"						
Meteorological Information	Wind: Northerly, Wind speed:6.4 knots, Temperature: 25°C CAVOK , Dew point: Not known					
Number of people on board	1 + 0	No. of people injured	1	No. of people killed	0

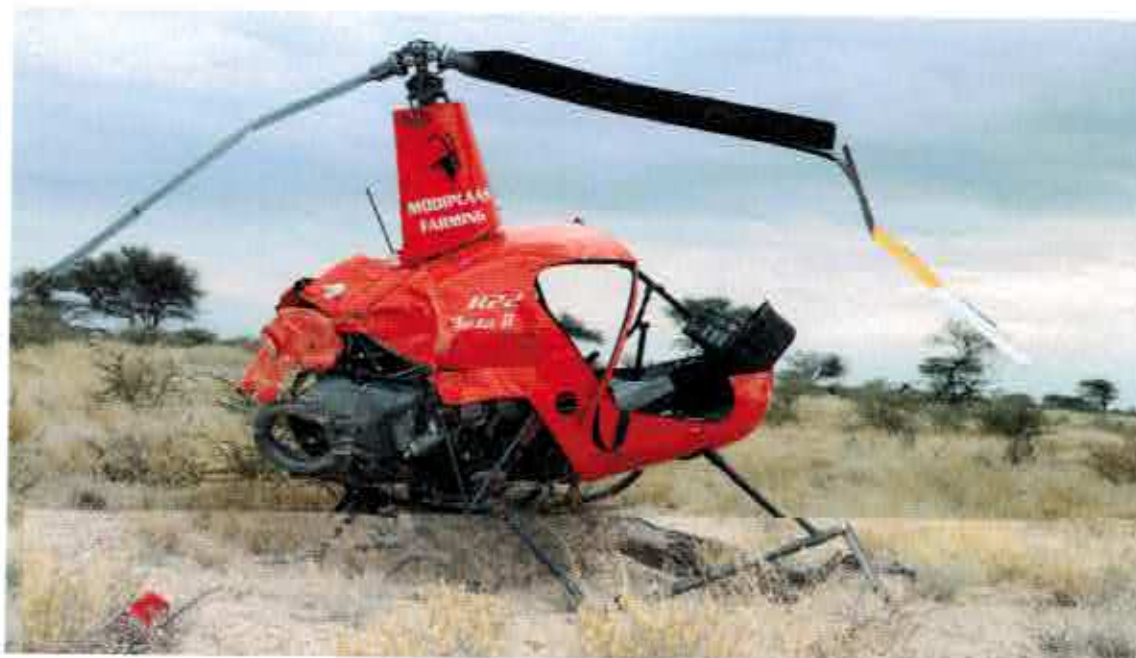
Figure 1. A photo showing the aircraft where it crashed after it struck a single phase electrical cable, the tail rotor system was cut off completely, the cockpit wind shield has shattered, the right landing skid is broken and the main rotor blades are broken into pieces due to impact forces with the aircraft structure and the ground.

- 2.1.5 The aircraft struck the single phase electrical cable with the landing skid, became uncontrollable, pitched nose down then ended up on its right hand side on impact.

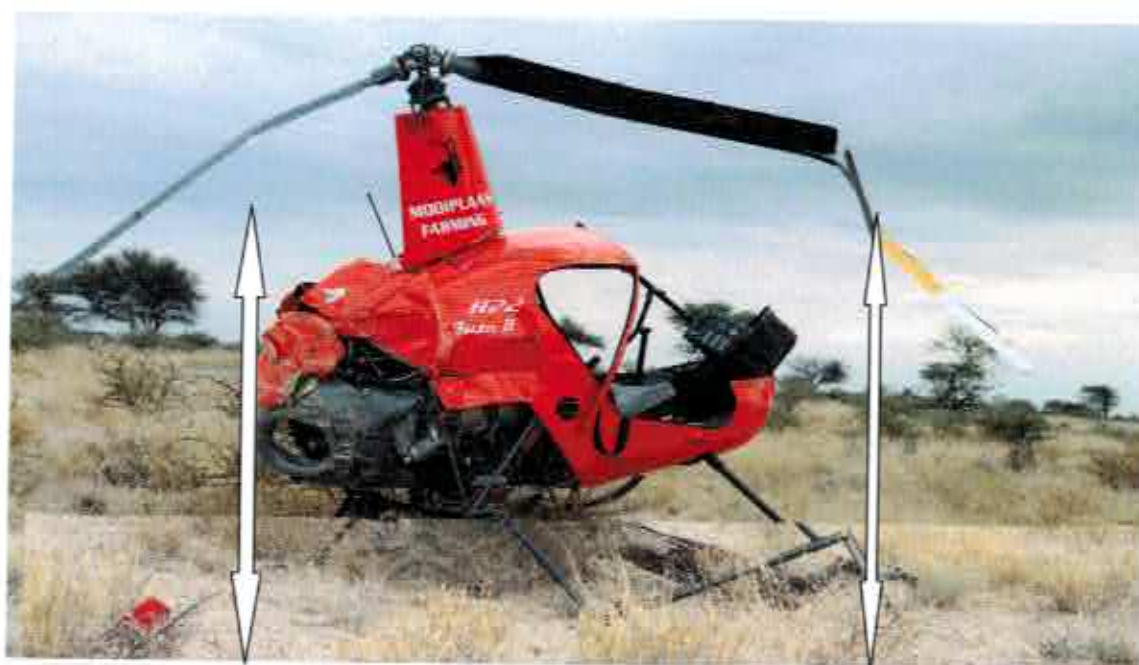
Figure 2. This photo shows the electrical cable that the aircraft struck and damages on the air frame and rotary system.

- 2.1.4 The aircraft was flying from the western to the easterly direction and there was a single phase electrical cable that runs from the south to the north direction.

4.1 Regulatory Authority (DCA): statistics shows that electrical wire accidents are a major contributing factor to helicopter accident in the world. It is therefore recommended that operators should draw up a check list for pilots doing aerial work, instructing them to do a reconnaissance flight and sign that they are aware of all the obstacle especially electrical cables and telephone wires that run through an area where operation is planned to take place.

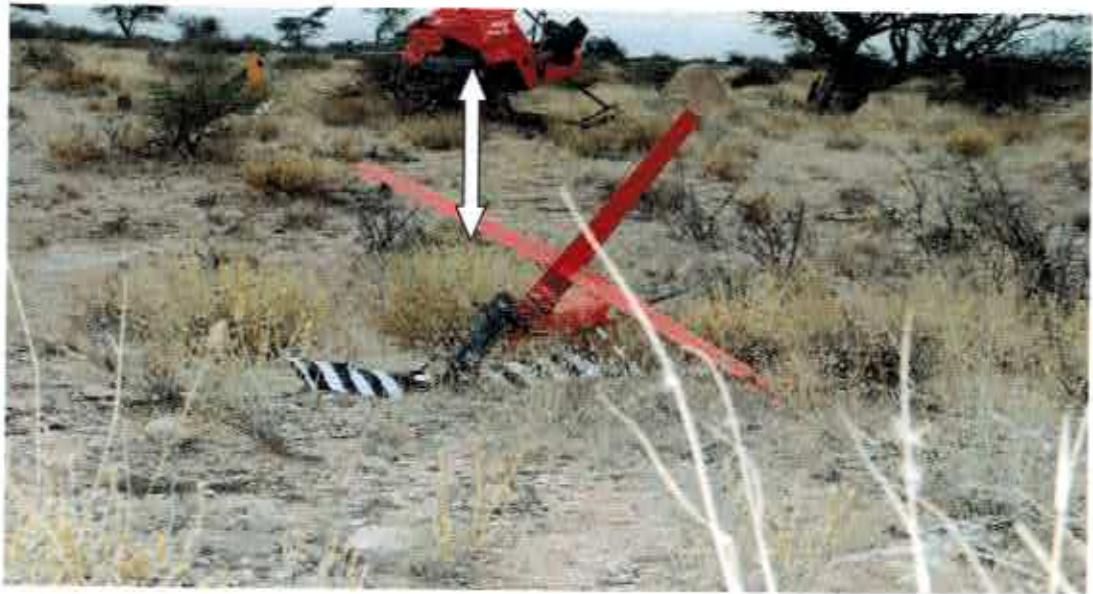
Figure 3. A photo showing the tail rotor system 33.1 metres away from the main wreckage

- 2.1.6 When the aircraft struck the power line and pitched nose down, the main rotor blade cut off the tail boom completely and it was found 43.1 metres away from the main wreckage in the southern direction which was the direction of rotation of the main rotor blades.

- 3.1.8 The tail boom was cut off by the main rotor blade completely from the structure before the impact and further damages to the aircraft were attributed to the impact forces.
