AIRCRAFT ACCIDENT INVESTIGATION
Private Bag 12042
Ausspannplatz
Windhoek
NAMIBIA

RE: AIRCRAFT INCIDENT REPORT

**DIRECTORATE OF AIRCRAFT ACCIDENT INVESTIGATIONS
ACCIDENT REPORT – EXECUTIVE SUMMARY**

Aircraft Registration	V5-HJB	Date of Accident	24 June 2014		Time of Accident	11:50 UTC
Type of Aircraft	ROBINSON R22 BETA 2	Type of Operation		Game capture		
Pilot-In-Command License Type	CPL (Helicopter)	Age	40	License Valid	Yes	
Pilot-In-Command Flying Experience	Total Flying Hours	4000.0 hrs		Hours on Type	3300.0 hrs	
Last point of departure	Farm Immenhof					
Next point of intended landing	Farm Immenhof					
Location of the accident site with reference to easily defined geographical points (GPS readings if possible)						
Farm Immenhof S 21° 06' 55" E 015° 35' 36"						
Meteorological Information	Wind: Northerly, Wind speed:6.4 knots, Temperature: 25°C CAVOK , Dew point: Not known					
Number of people on board	1 + 0	No. of people injured	1	No. of people killed	0

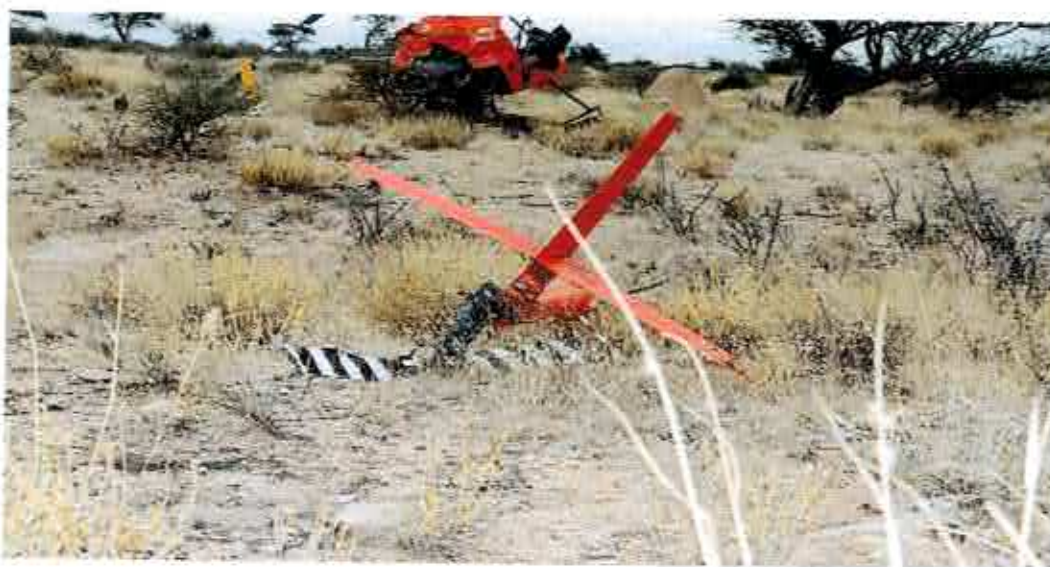
- 1.12.1 The aircraft was destroyed during the impact.
- 1.12.2 The distance from the electrical cable the aircraft struck to the wreckage was 50.1 metres in the direction of flight.
- 1.12.3 The tail boom and other small parts from the tail were found 33.1 metres away from the Wreckage.
- 1.12.4 The two main rotor blades remained attached to the hub but exhibited significant damage consistent with contacting the ground while under power.

Figure 1. A photo showing the aircraft where it crashed after it struck a single phase electrical cable, the tail rotor system was cut off completely, the cockpit wind shield has shattered, the right landing skid is broken and the main rotor blades are broken into pieces due to impact forces with the aircraft structure and the ground.

- 2.1.6 When the aircraft struck the power line and pitched nose down, the main rotor blade cut off the tail boom completely and it was found 43.1 metres away from the main wreckage in the southern direction which was the direction of rotation of the main rotor blades.

- 3.1.8 The tail boom was cut off by the main rotor blade completely from the structure before the impact and further damages to the aircraft were attributed to the impact forces.
